DOCUMENT NO. D290-75303-2 Vol. III

TITLE IUS Program: Shock Analyses and Shock Tests

This volume of D290-75303-2 contains shock analysis and shock test results performed in support of the Inertial Upper Stage (IUS) program.

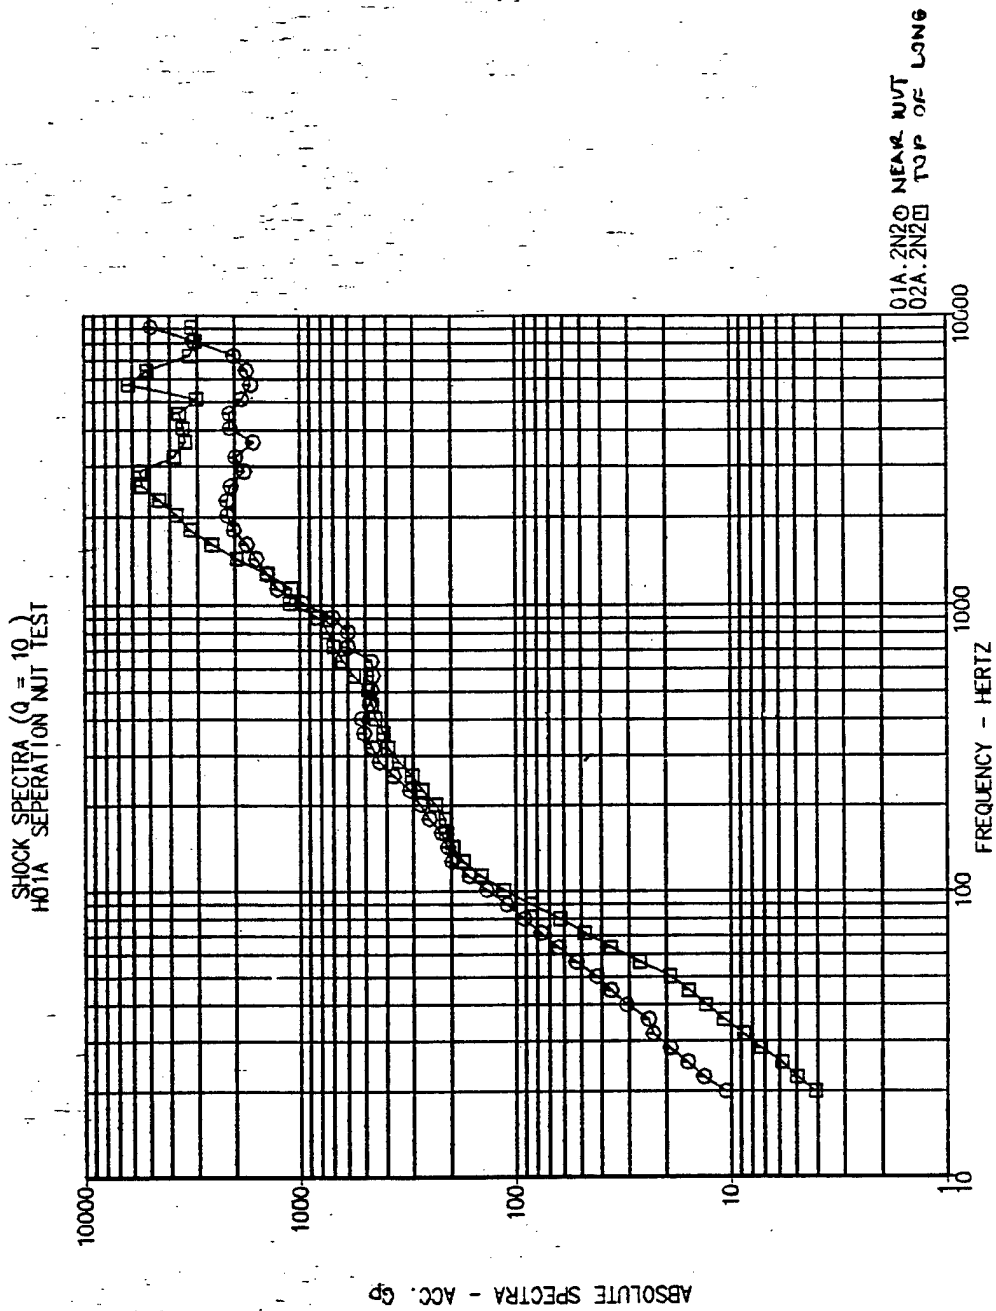
FIGURE 8A ATTENUATION EVALUATION
LOCATION 1 AND 2 AXIAL
2 NUT FIRING

Figures 8, 9 and 10 compare single nut firing spectra near nut and at top of longeron (20 inches from nut). Attenuation is noted above 200 Hz for the radial and tangential directions. However, magnification is apparent in the axial direction. Figures 8A, 9A and 10A show the same comparison for a 2 nut firing.

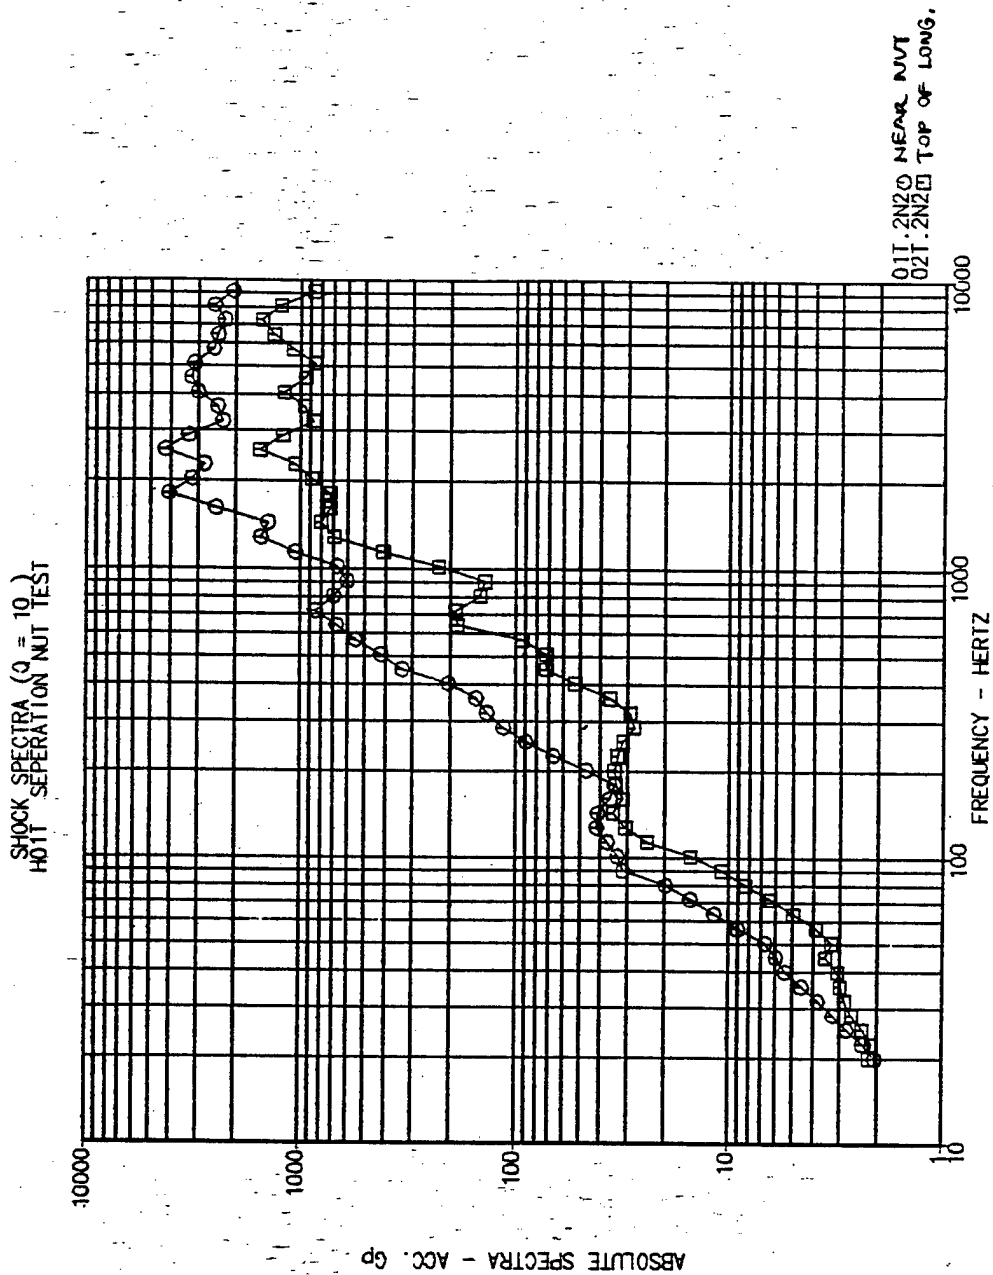
26-JAN-84 07:50:57
FIGURE 10A ATTENUATION EVALUATION
LOCATION 1 AND 2 TANGENTIAL
Z NUT FIRING

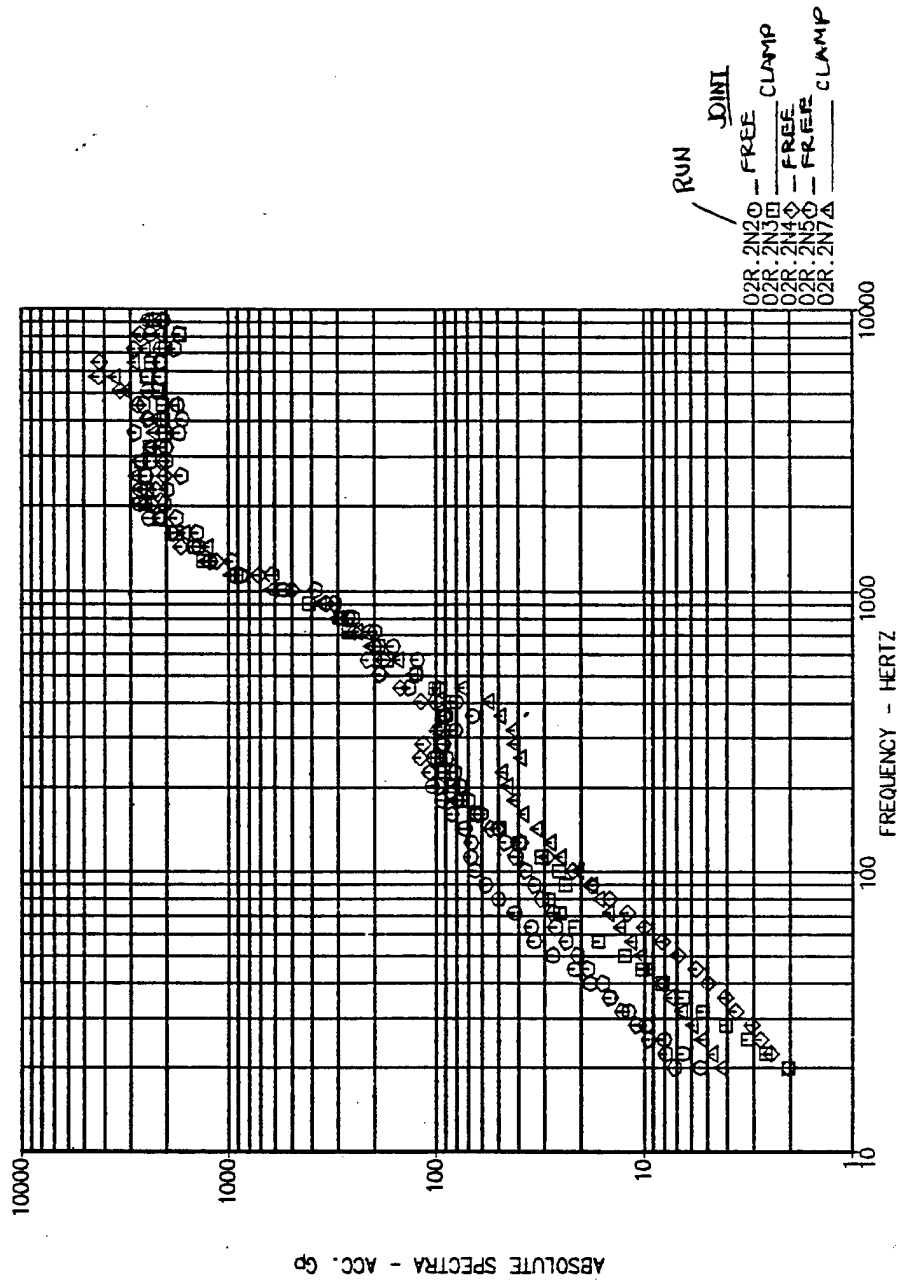
FIGURE 15 Z NUT FIRING
LOCATION Z RADIAL
JOINT FREE & CLAMPED

Figures 14, 15, and 16 show the shock spectra at location 2 for the 2 nut firing, three directions. Tests were run with the separation joint free and clamped. A significant difference in axial response was noted between clamp and free as shown in Figure 14.

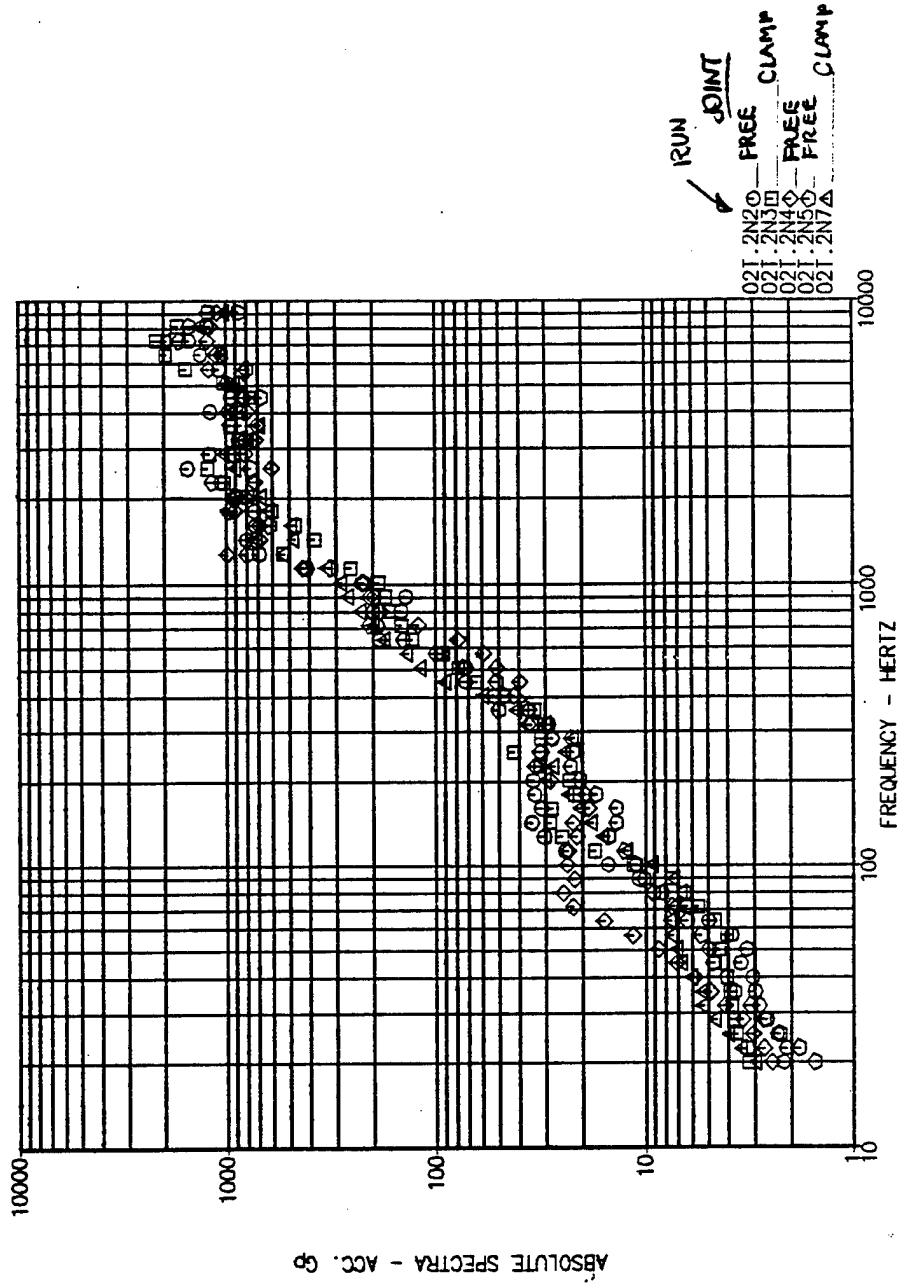
FIGURE 16 2 NUT FIRING
LOCATION 2 TANGENTIAL
JOINT FREE & CLAMPED

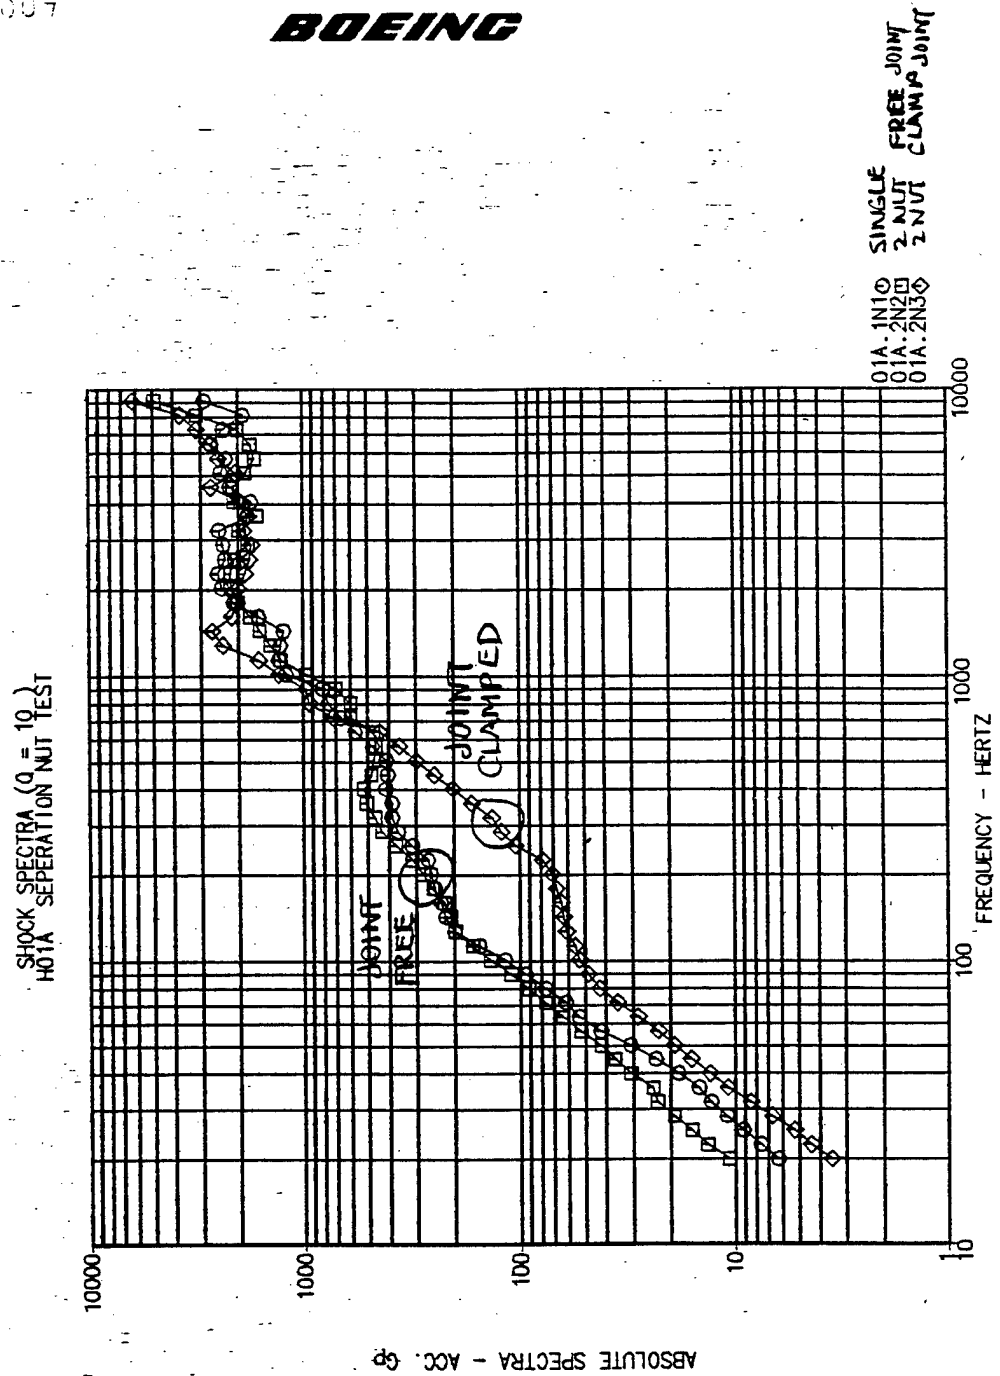
FIGURE 17 SINGLE VS. 2 NUT SHOCK
LOCATION 1 AXIAL
JOINT FREE AND CLAMPED

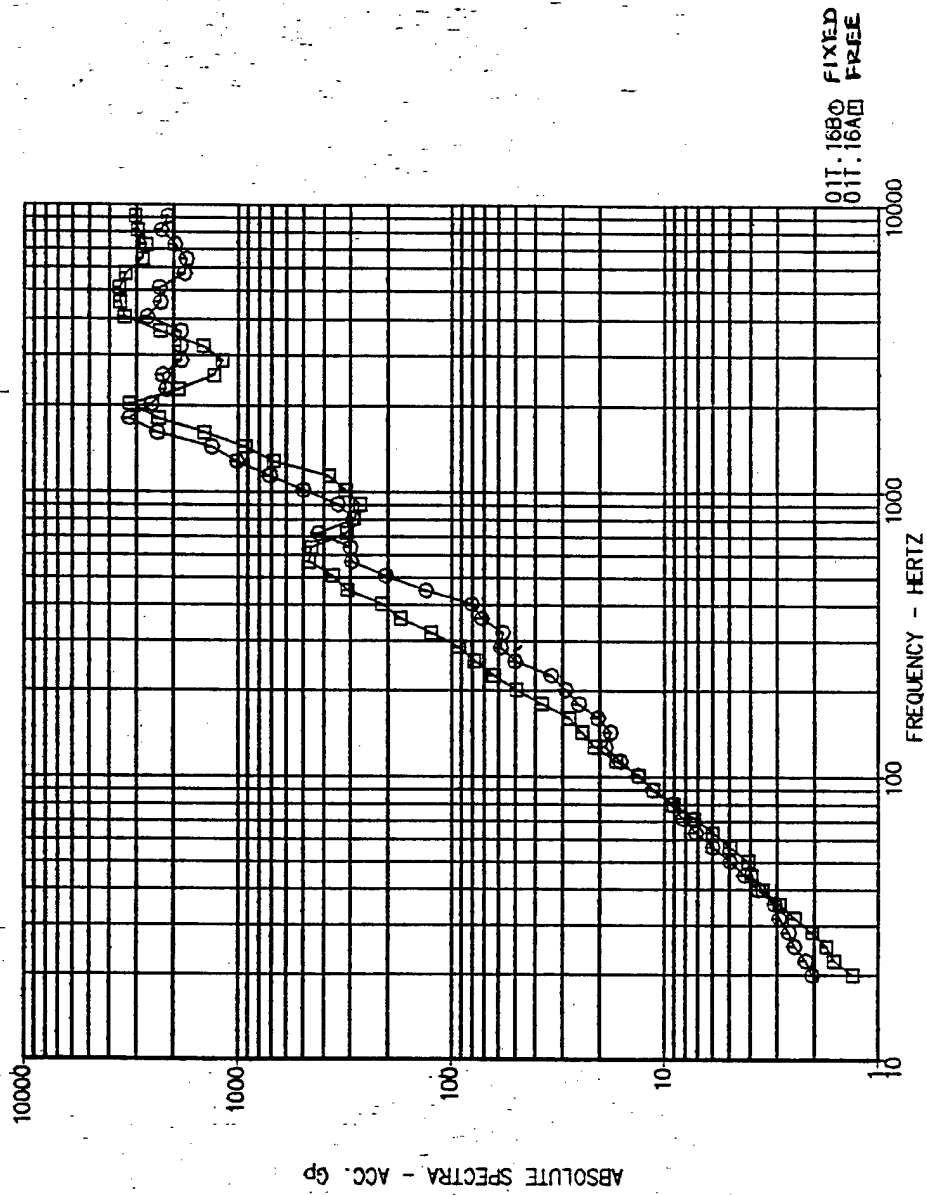
FIGURE 23 SINGLE NUT FIRING
FIXED NUT VS. FREE NUT
LOC. 1. TANGENTIAL

3. The shock response was a function of the nut fired. Differences in the order of 10 dB were noted in the axial direction. The higher levels were caused by the fixed nut. See Figures 23 through 25. Similar differences were observed between the separation joint free and clamped. See Figures 11 and 14.

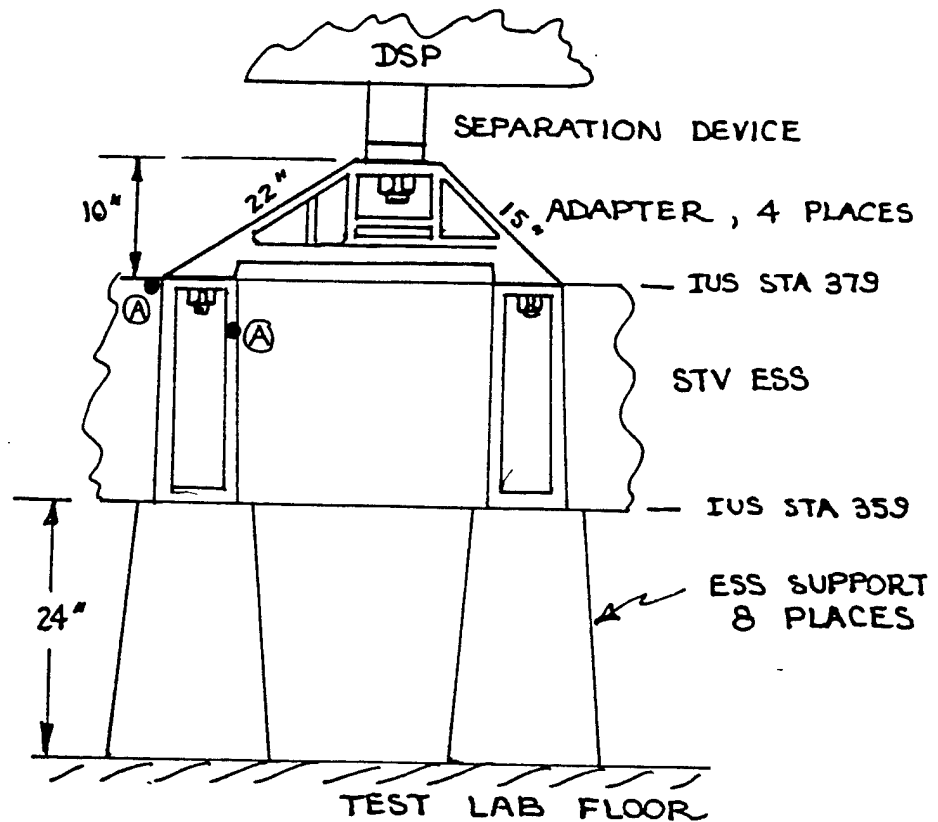
FIGURE 2-1
TEST SETUP

Ⓐ ACCELEROMETERS, SEE FIGURE 2-2

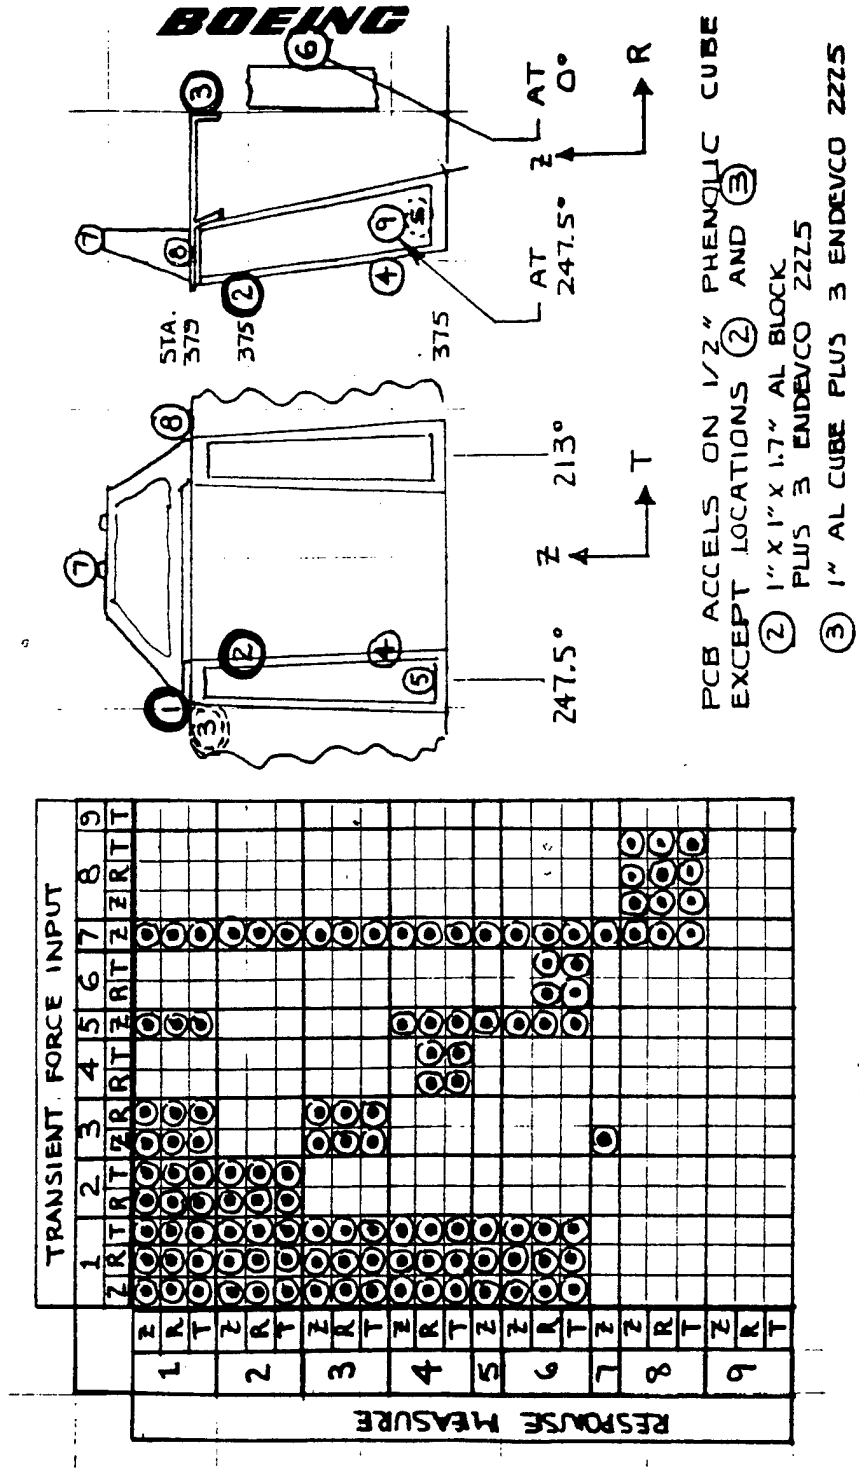
FIGURE 3-1 CONFIGURATION 1 MEASUREMENTS

- DATA TAKEN
- DATA PLOTTED, 120 GRAPHS

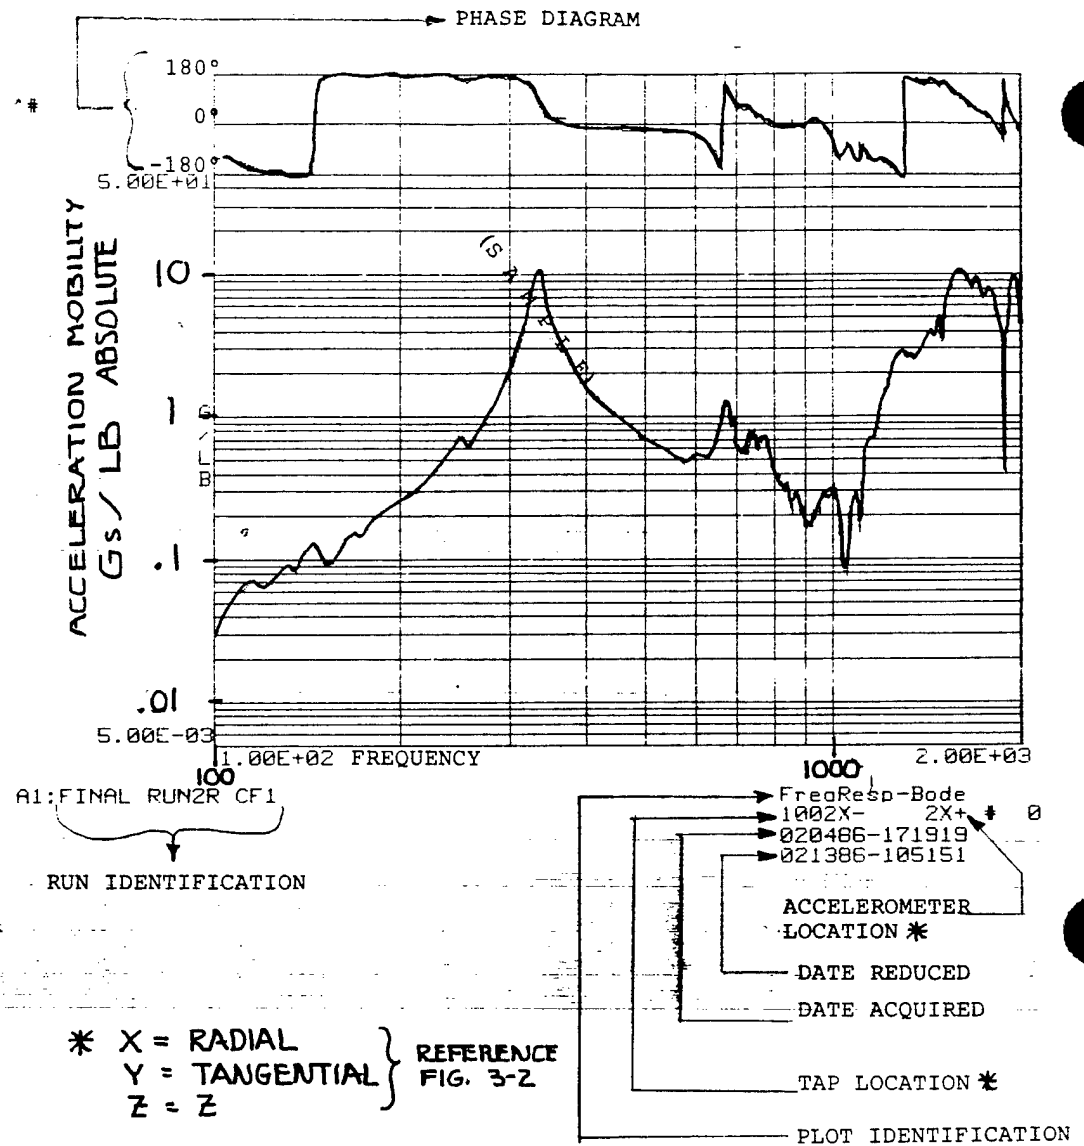
FIGURE 3-3
ACCELERATION MOBILITY GRAPH

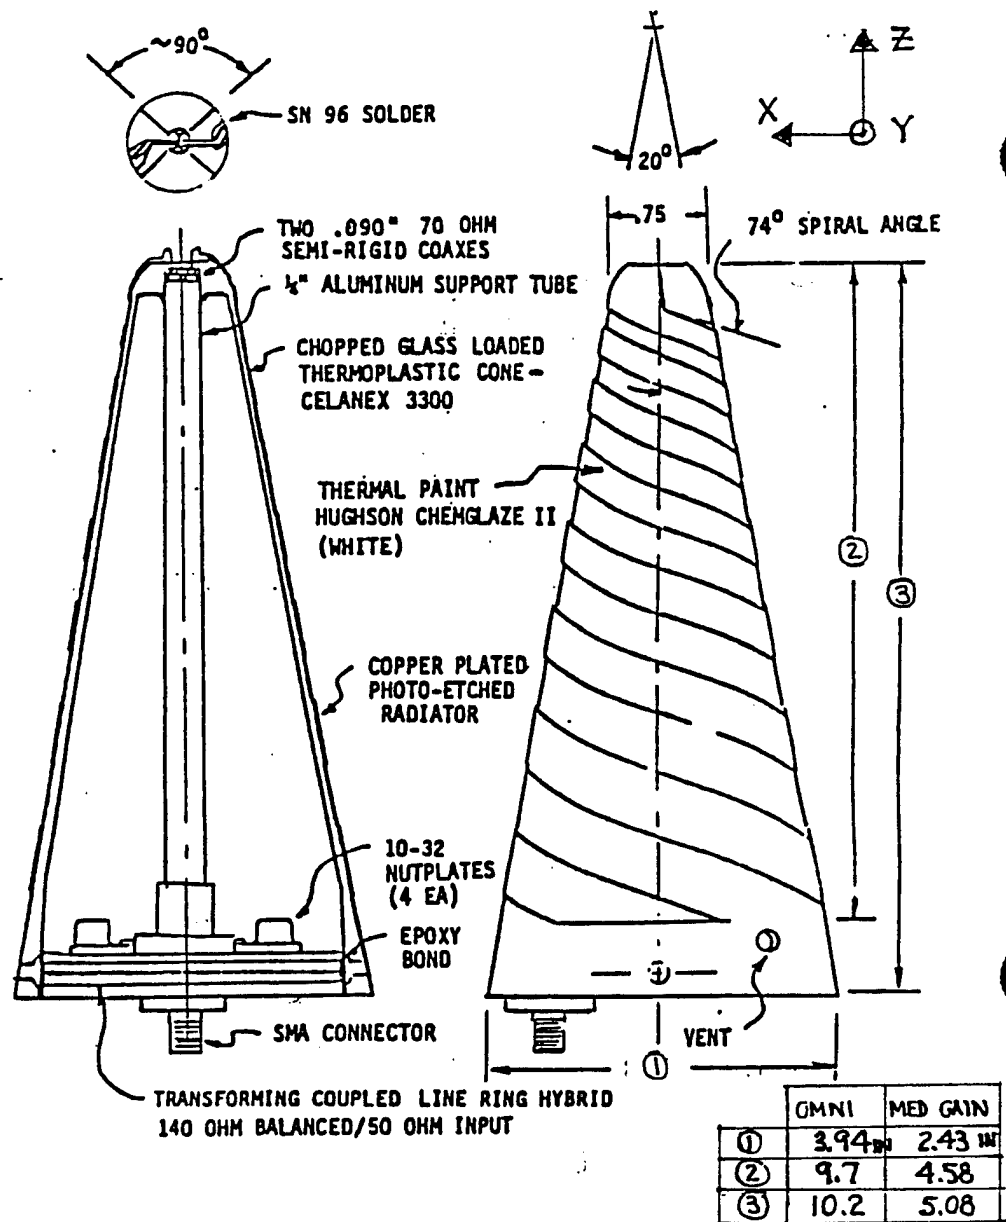
Medium Gain Antenna shown, Omni Antenna construction similar

FIGURE 5-19 ANTENNA CONSTRUCTION

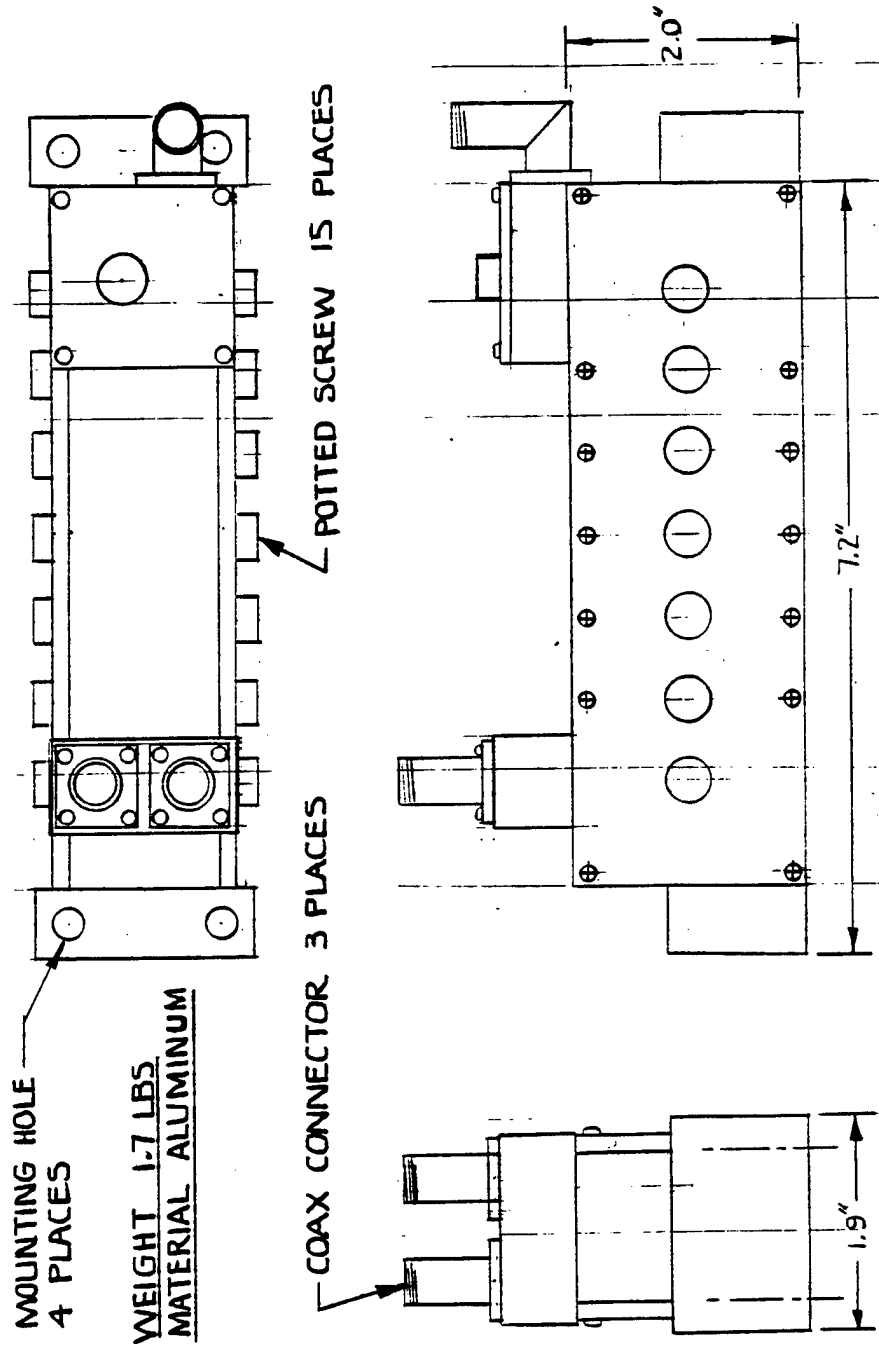
FIGURE 5-21
DIPLEXER CONSTRUCTION

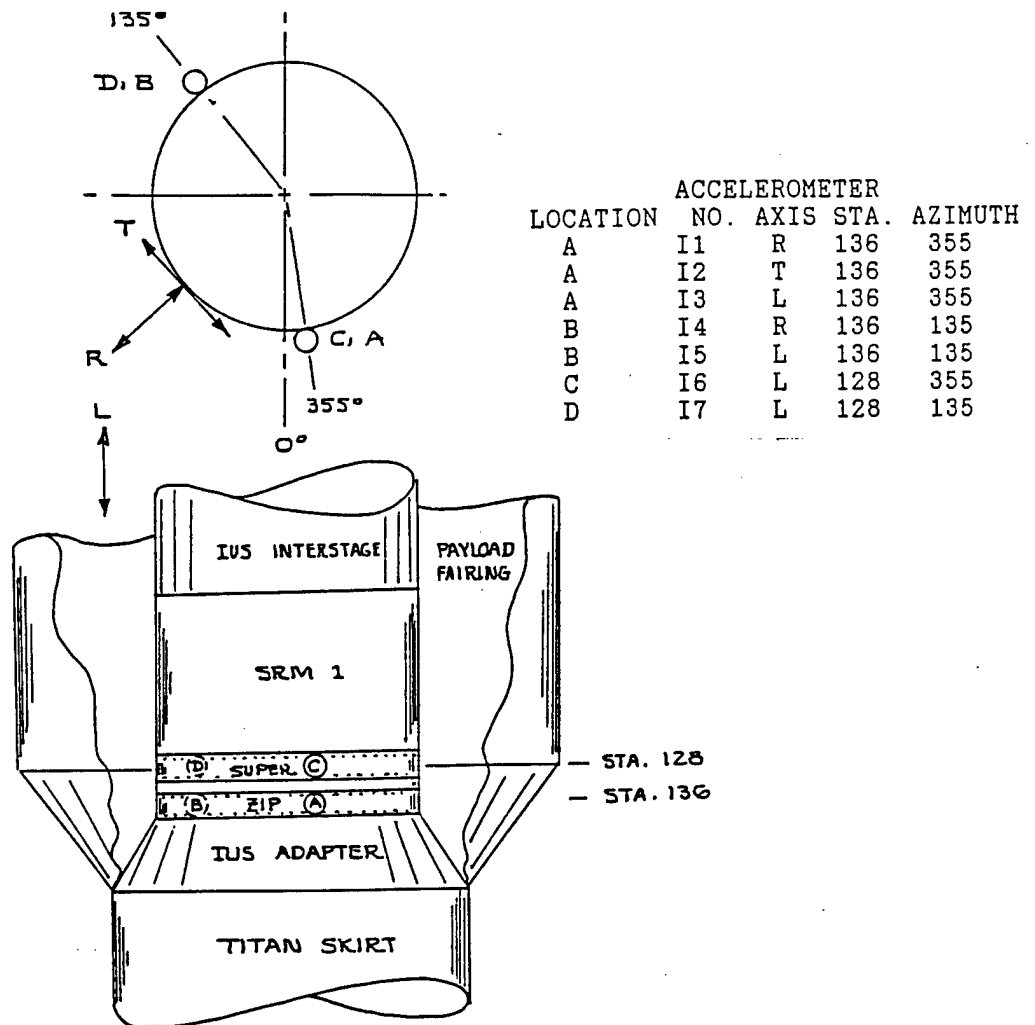
FIGURE 1
IUS ACCELEROMETER LOCATIONS
TITAN 4 PAYLOAD FAIRING SEPARATION TEST
JANUARY 1988

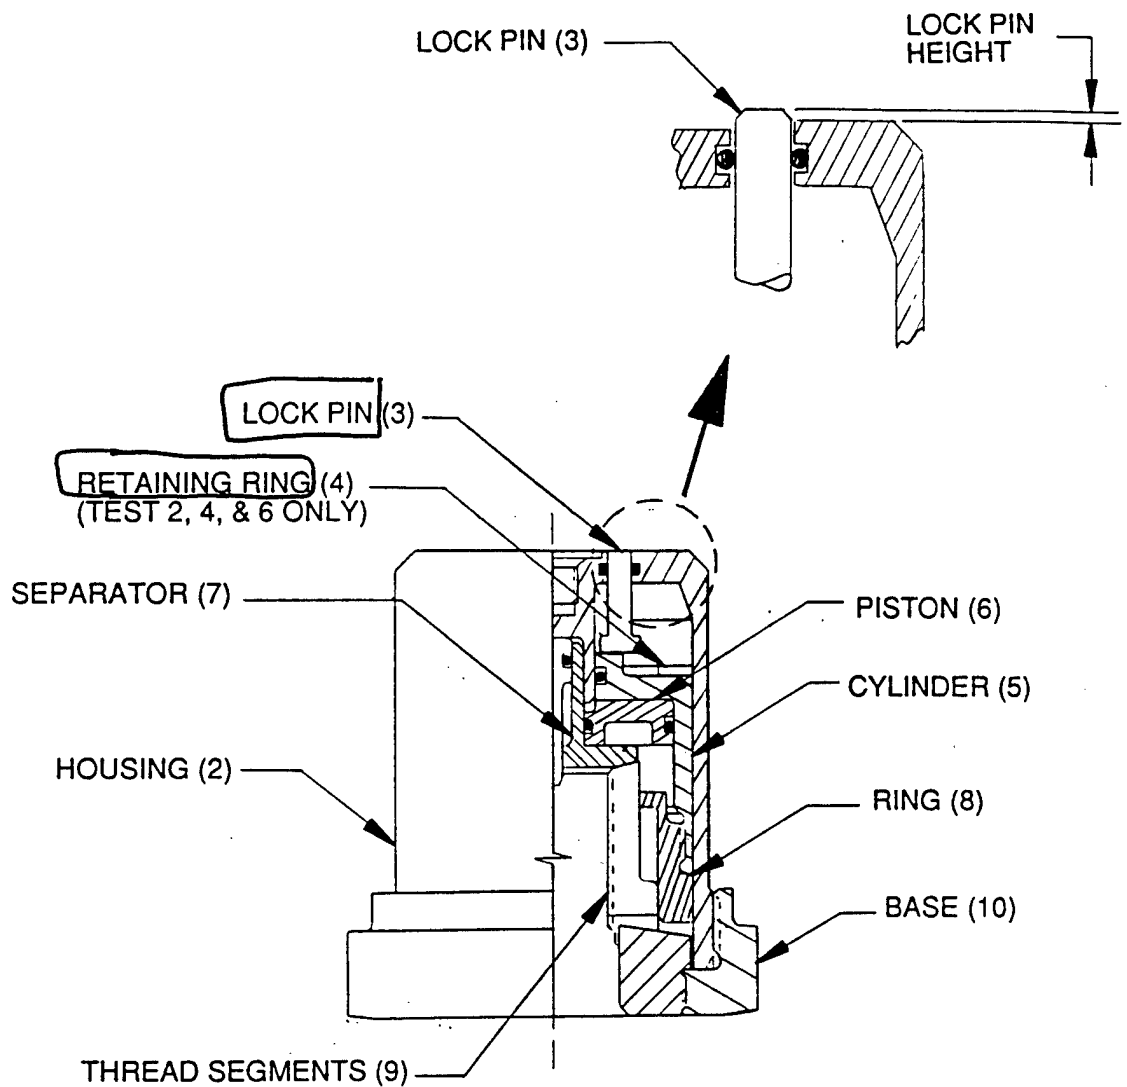
FIGURE 5
ASSEMBLED SEPARATION DEVICE

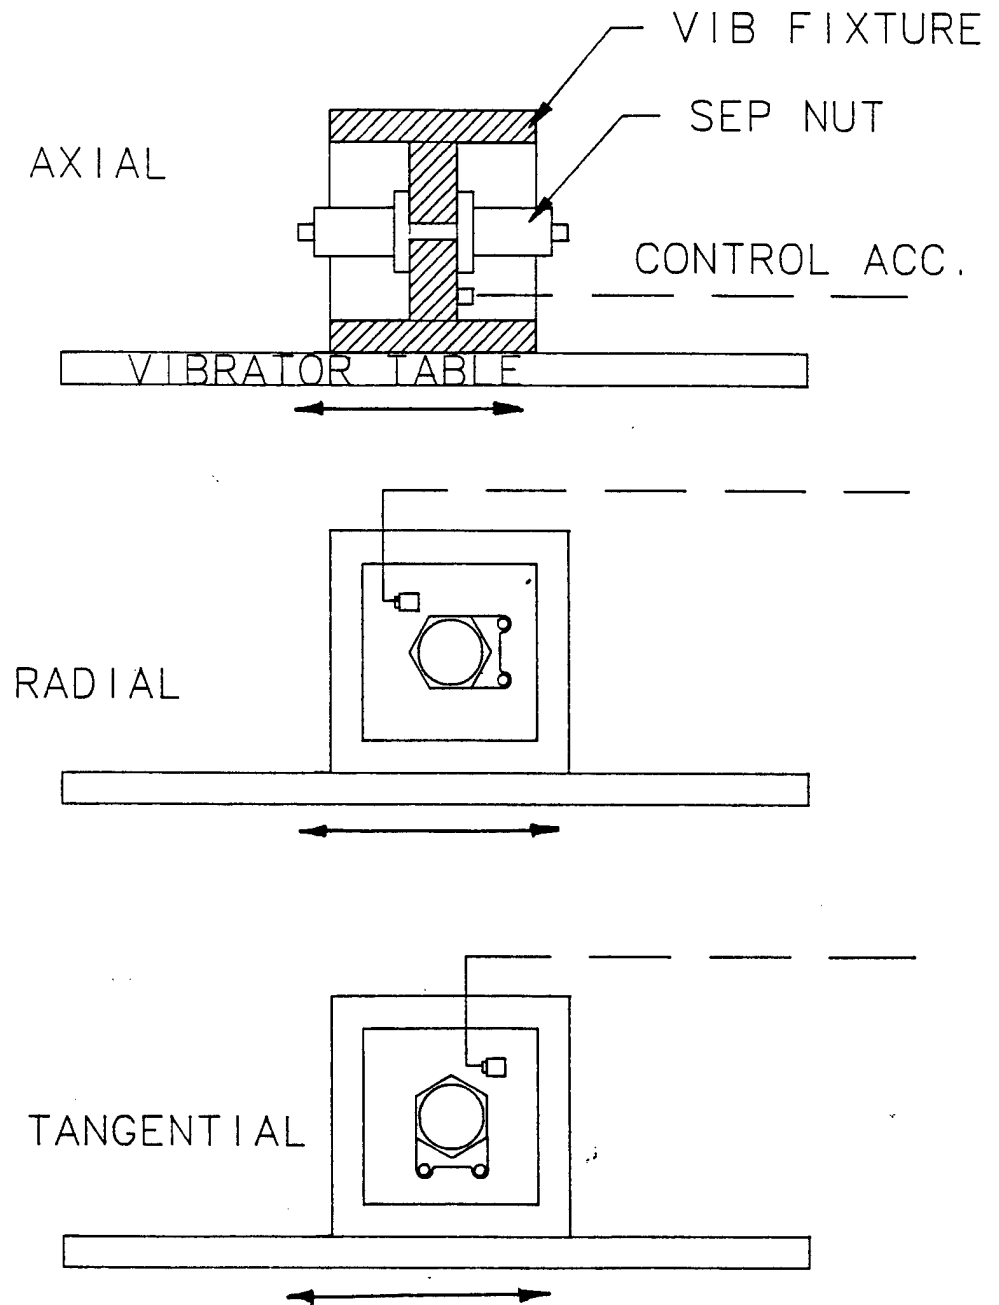
IUS SEPARATION NUT TEST VIBRATION TEST SET-UP

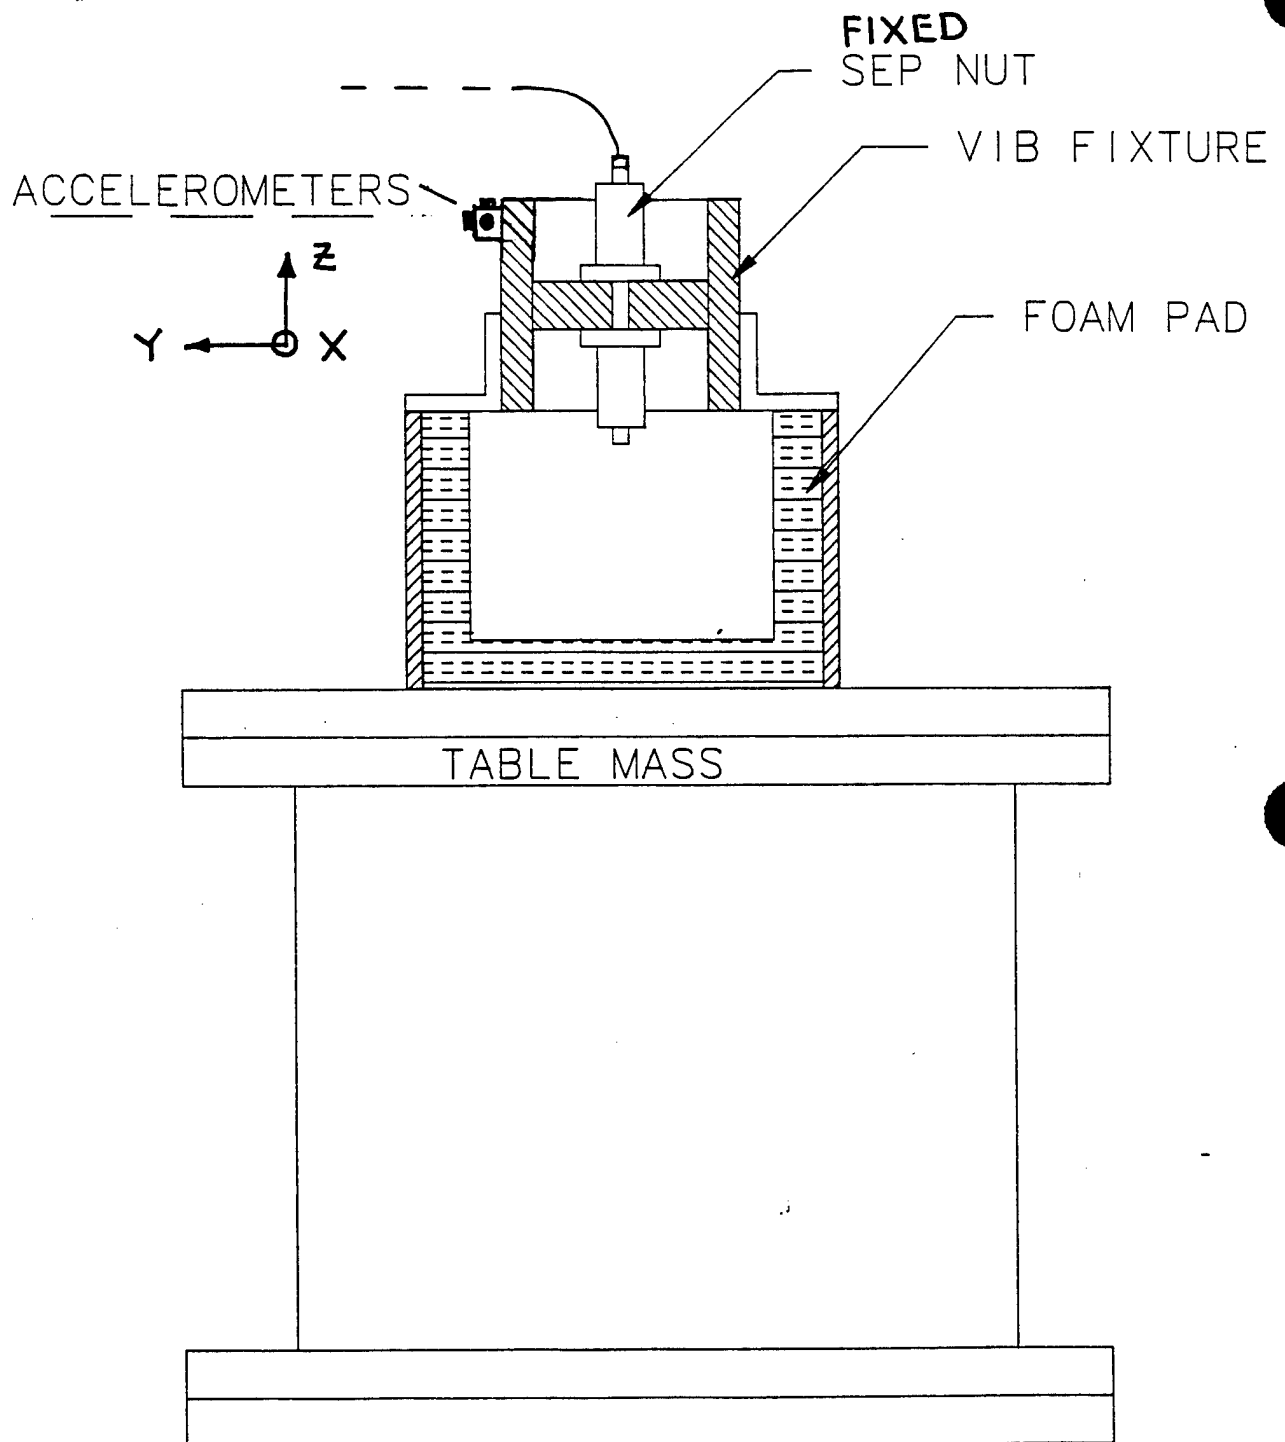
IUS SEPARATION NUT TEST PYRO-SHOCK TEST SET-UP

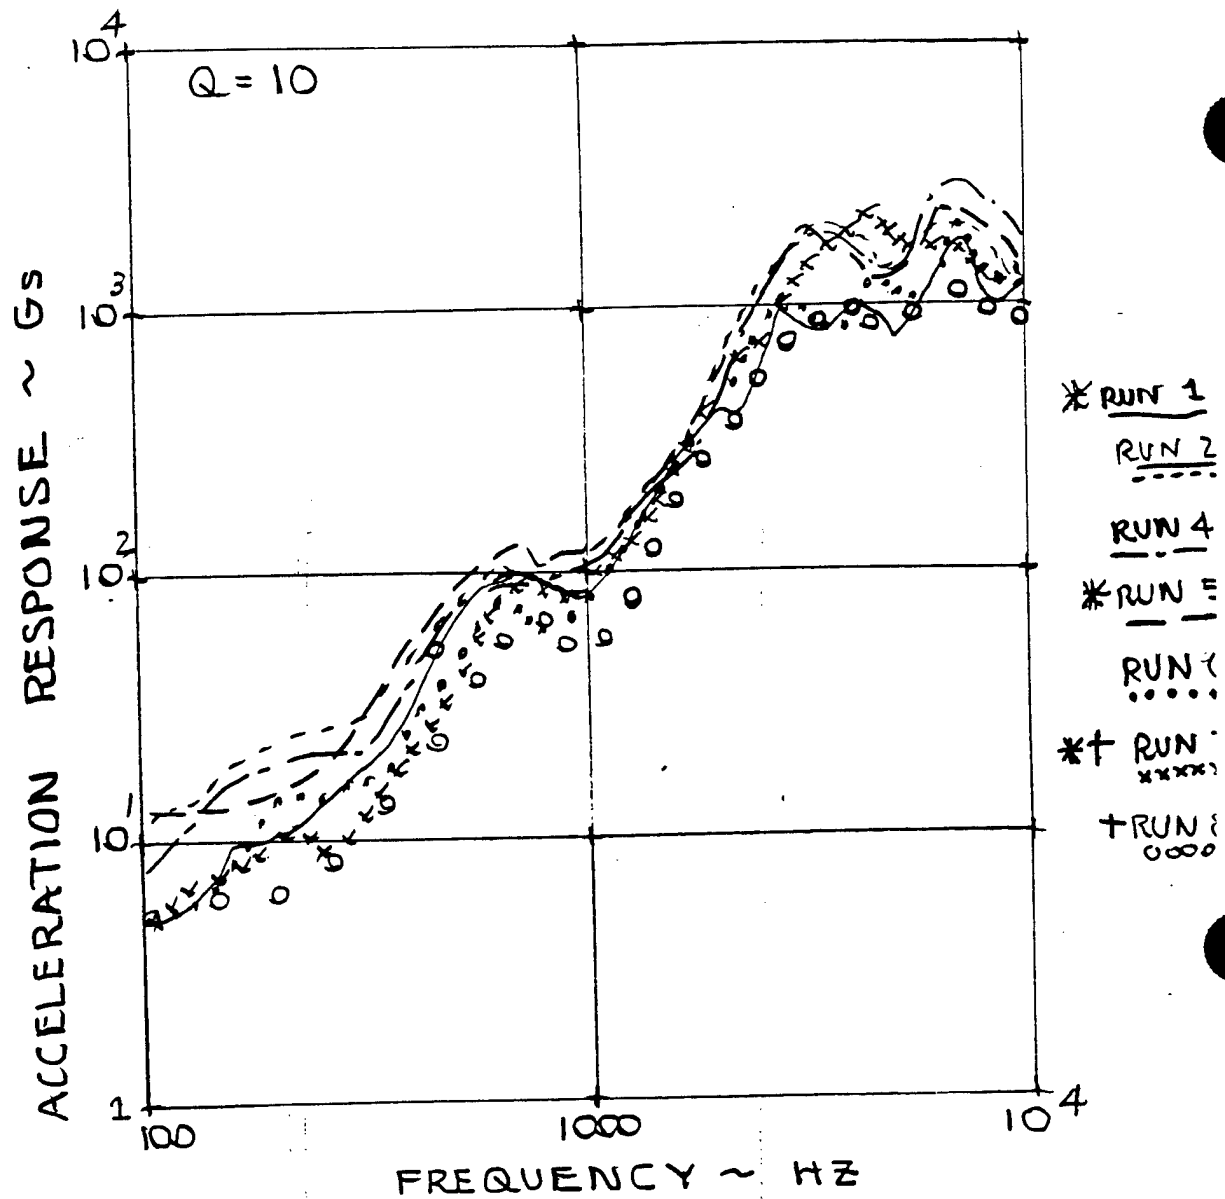
* WITHOUT RETAINER + FREE NUT REMOVED

SHOCK SPECTRUM COMPARISONS IUS STAGE 1/2 SEPARATION NUTS MEASUREMENT IX

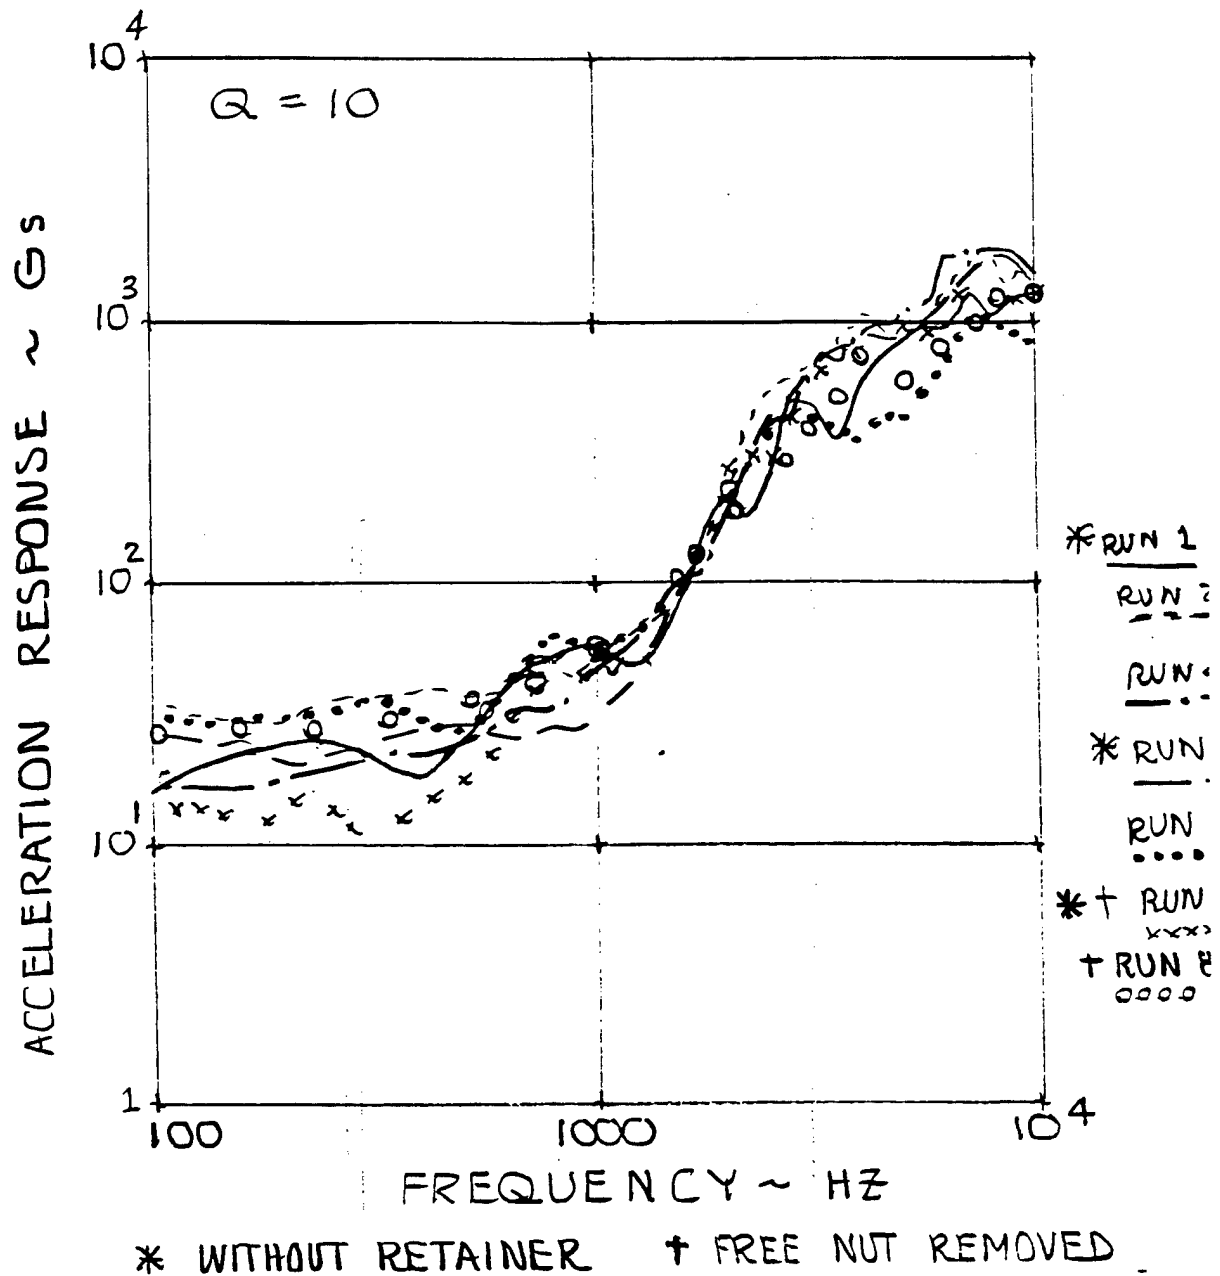
SHOCK SPECTRUM COMPARISONS
IUS STAGE 1/2 SEPARATION NUTS
MEASUREMENT 1Y
